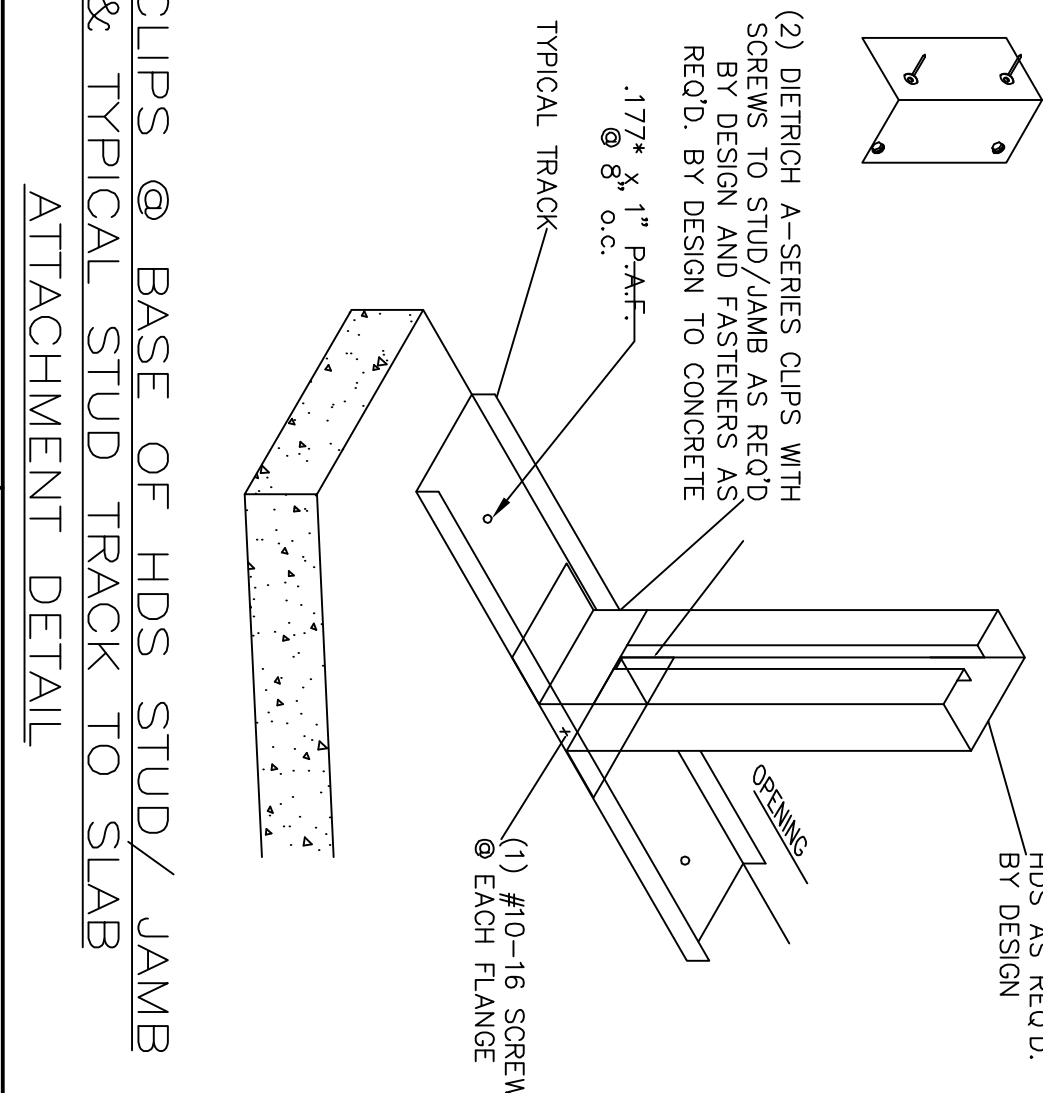
CLIPS @ BASE OF HDS STUD/ JAMB
& TYPICAL STUD TRACK TO SLAB
ATTACHMENT DETAIL

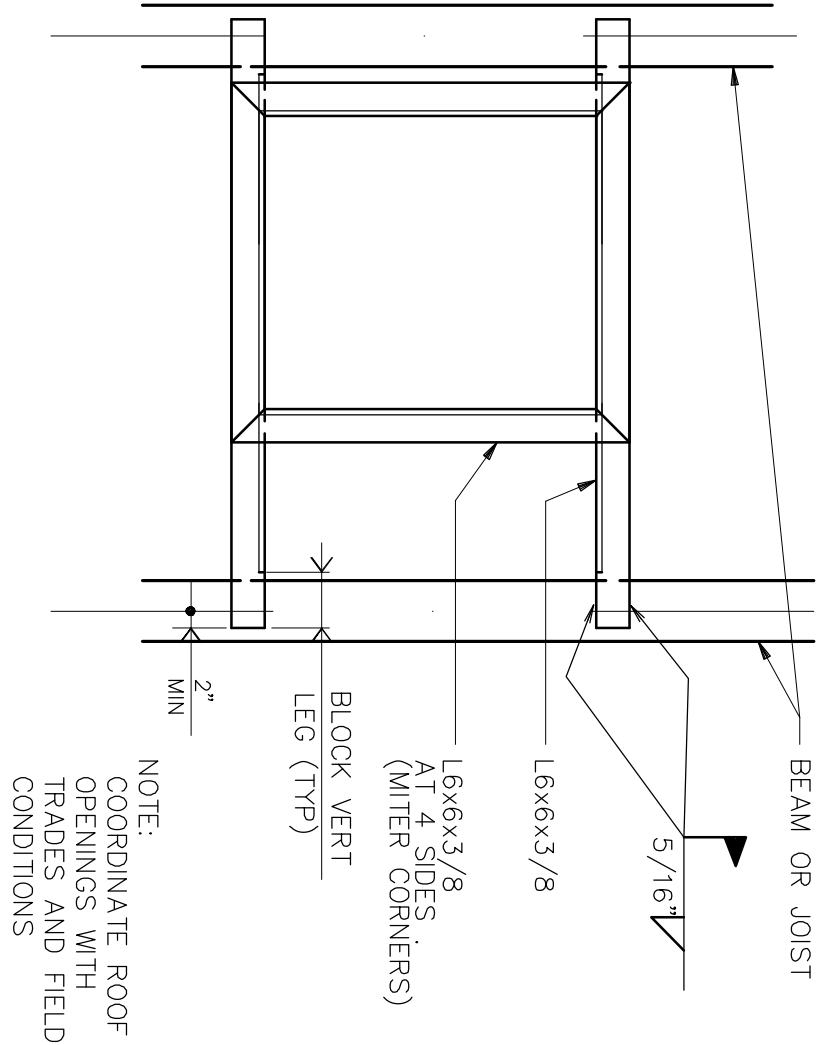
FRAMED ROOF OPNG DETAIL

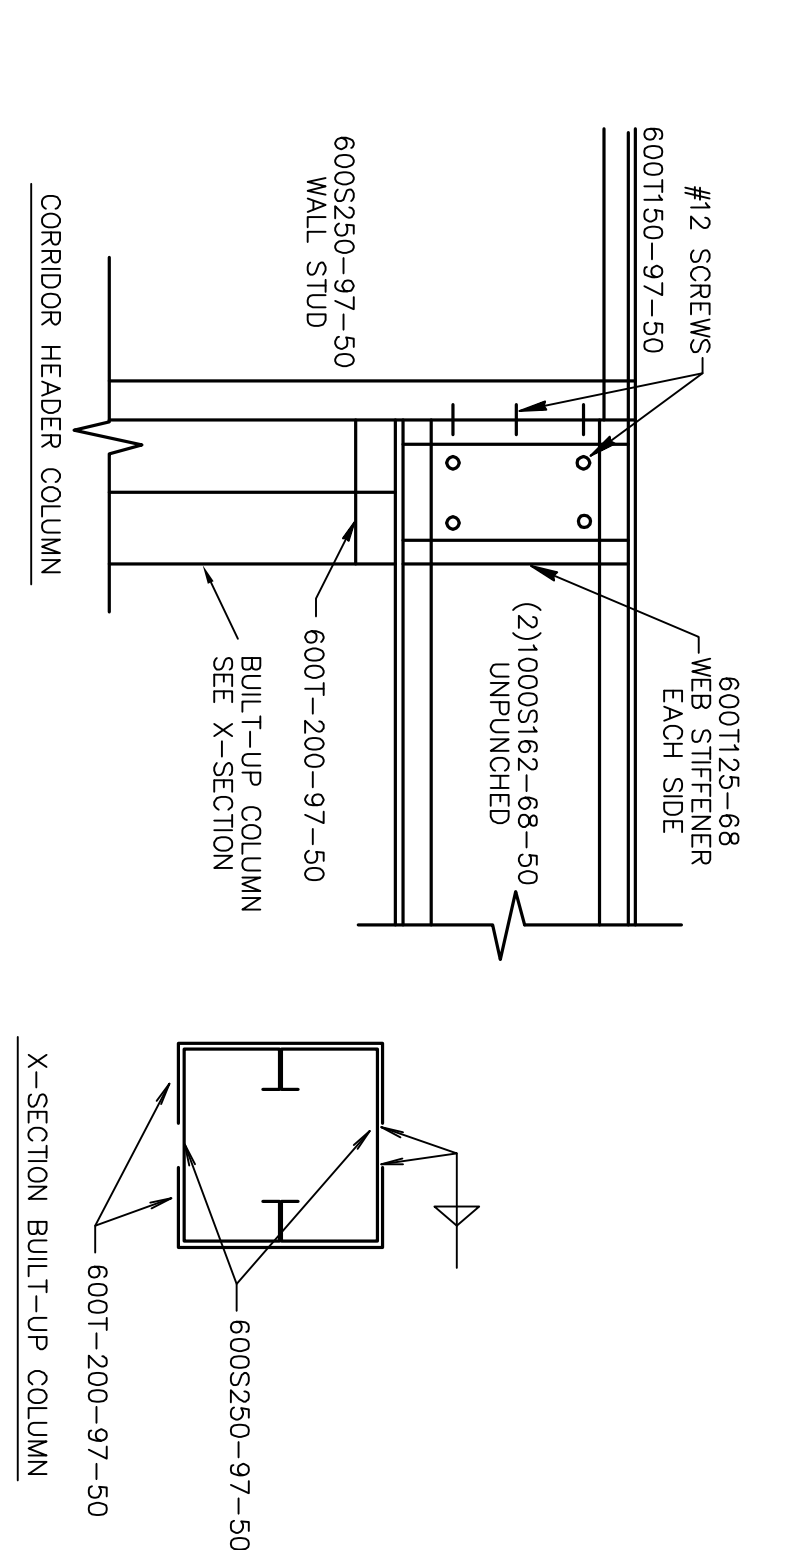
1 TYPICAL CORRIDOR LOAD BEARING HEADER/COLUMN DETAIL
S0.2

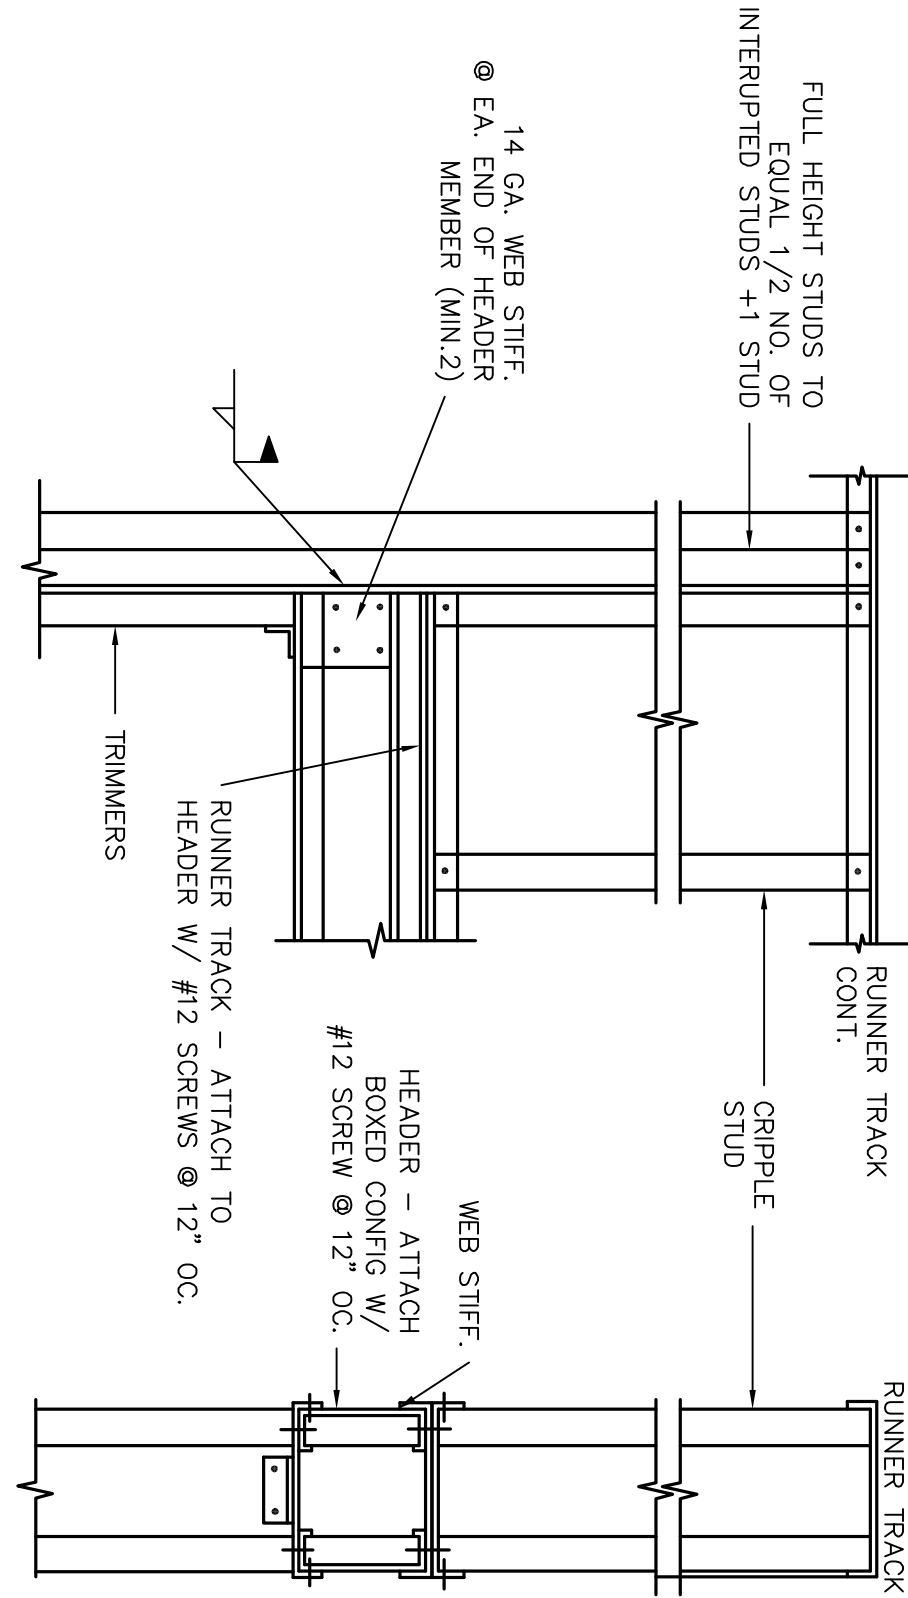
2 TYPICAL LOAD BEARING HEADER DETAIL
S0.2

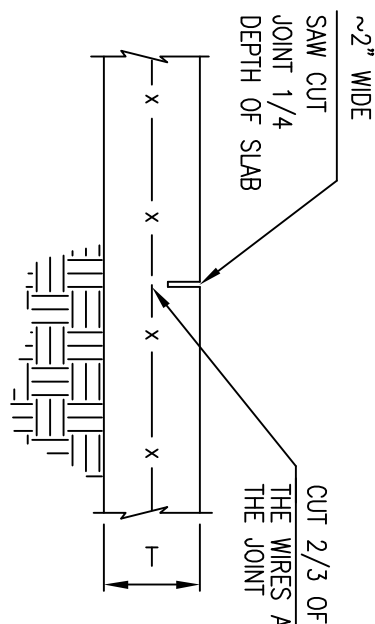
CONTRACTION JOINT
CT on PLAN

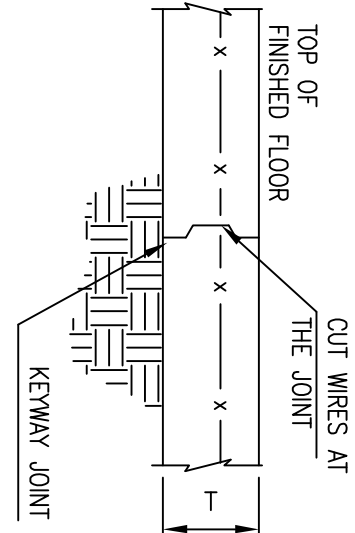
CONSTRUCTION JOINT
CU on PLAN

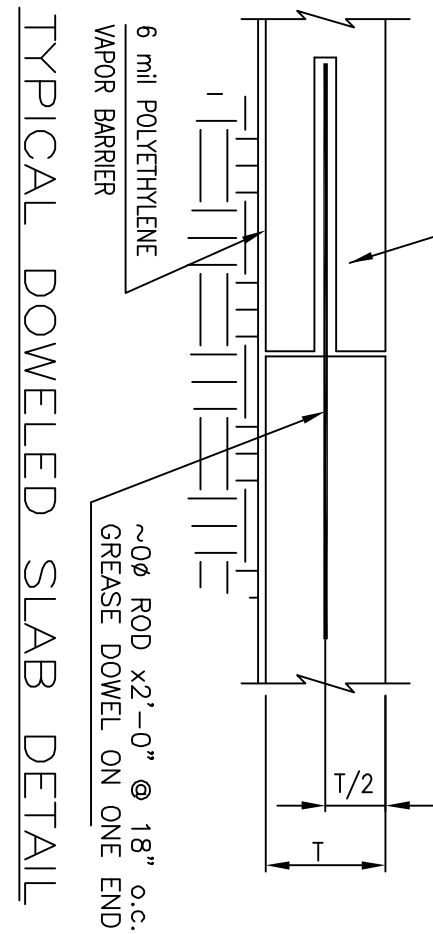
TYPICAL DOWELED SLAB DETAIL

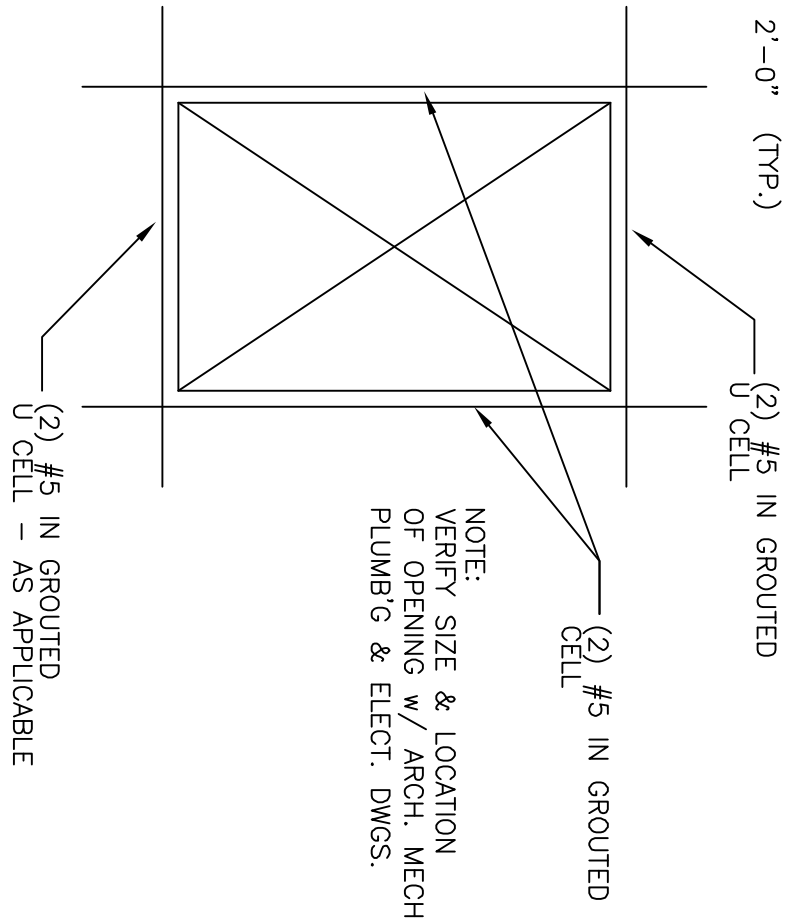
TYPICAL DETAIL OF ADDITIONAL
REINFORCING AROUND OPENING
IN MASONRY WALLS

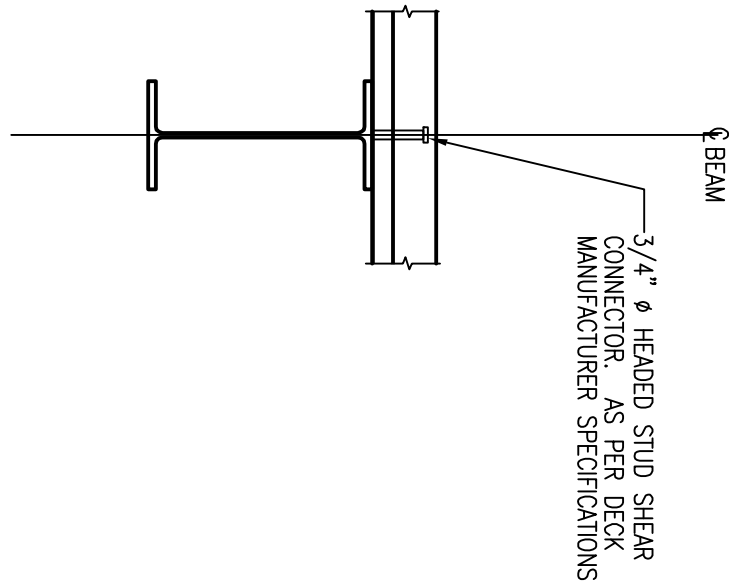
TYPICAL STUD PLACEMENT ON BEAMS

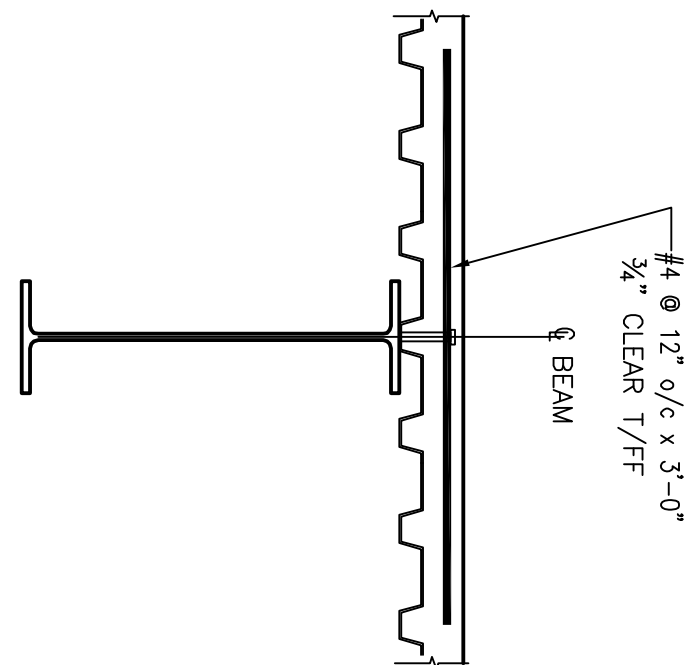
TYPICAL BEAM/ REBAR DETAILS
PROVIDE REBARS AS INDICATED OVER ALL WF
MEMBERS SHOWN ON THE FLOOR FRAMING PLAN.

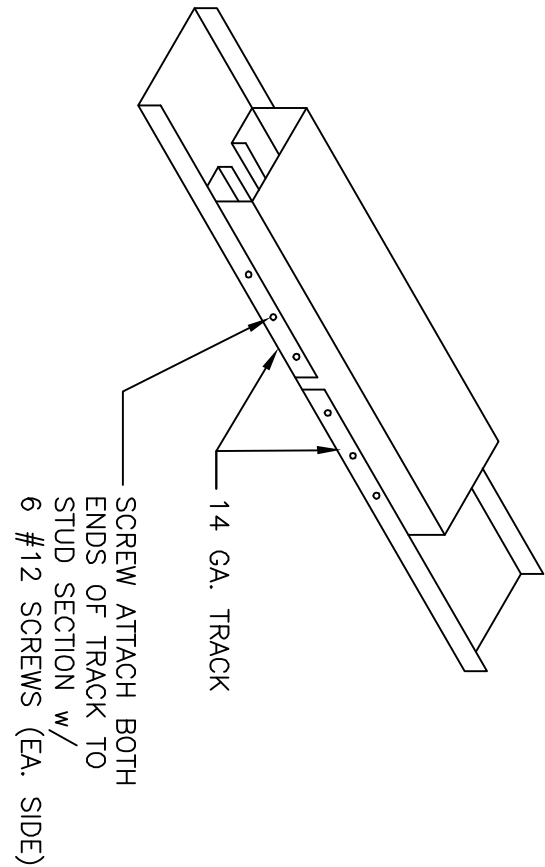
TYPICAL TRACK SPLICE DETAIL

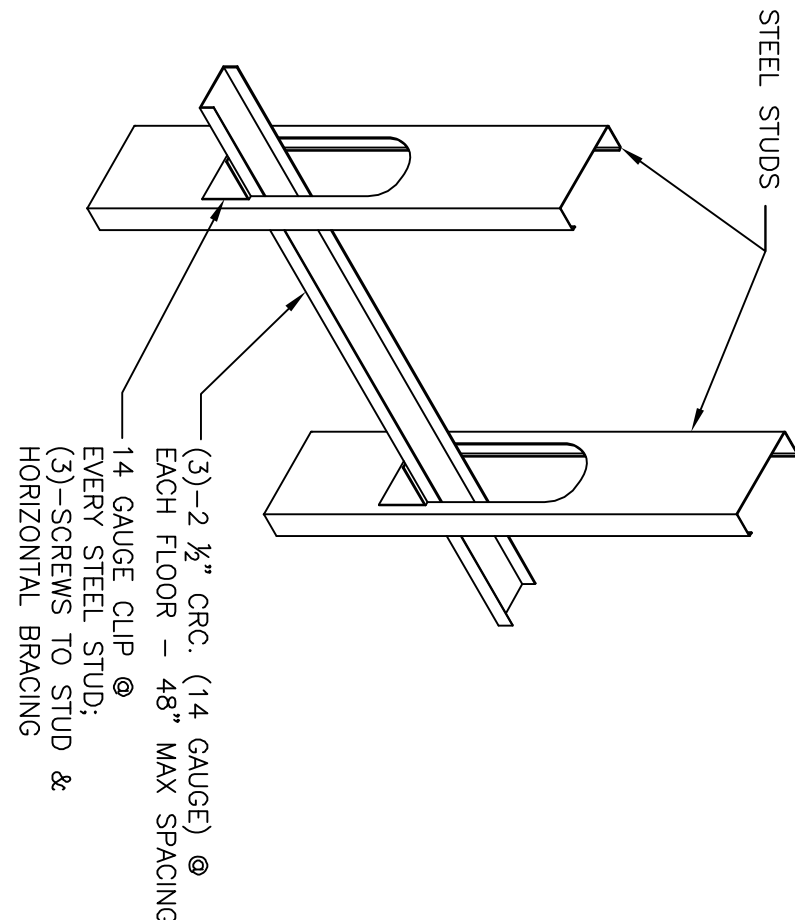
TYPICAL HORIZONTAL BRACING DETAIL

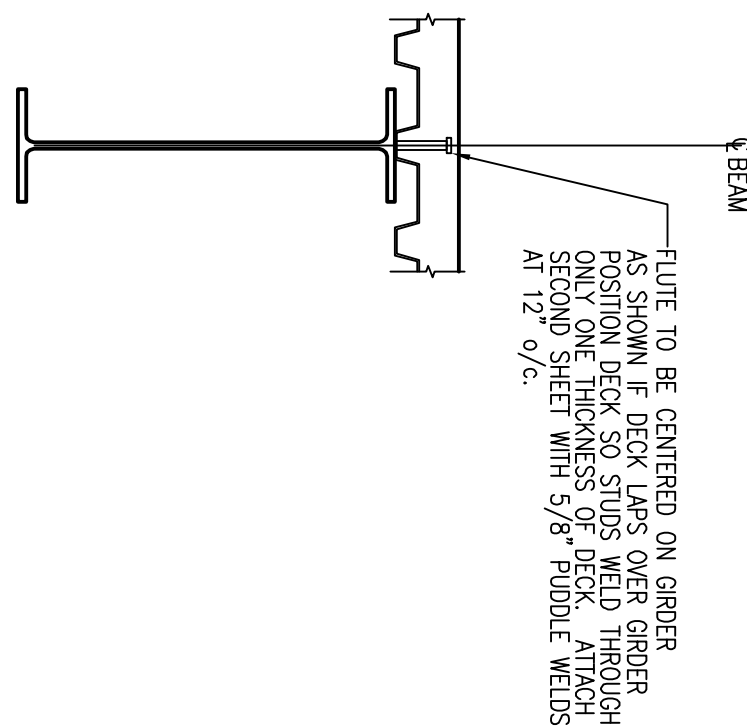
TYPICAL STUD PLACEMENT ON GIRDERS
